# Using a Porcelain Furnace to Debond Cement-Retained Implant Crown from the Abutment after Screw Fracture: A Clinical Report

The purpose of this clinical report was to describe a patient situation where the cement-retained, implant-supported crown was retrieved by debonding from the abutment using a porcelain furnace after a screw fracture.

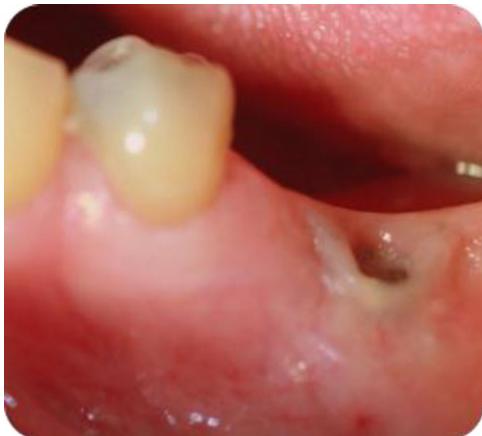
**Figure 1** Initial presentation of fractured screw and implant-supported crown.

A 62-year-old Caucasian man presented to The Ohio State University College of Dentistry Dental Faculty Practice Clinic with an avulsed cement-retained, implant-supported ceramo-metal restoration on left mandibular first molar (Fig 1). His record indicated that a 4.3 mm diameter implant (Replace Select; Nobel Biocare, Zurich, Switzerland) was placed in 2006. Two-stage implant protocol was strictly followed, and at 4 months the implant was uncovered, and a healing abutment was placed. A closed-tray impression technique was used, and the final impression was made with a polyether impression material (Impregum Penta; 3M ESPE, St. Paul, MN). The definitive restoration was cemented using zinc oxide eugenol temporary cement (TempBond Original; Kerr Corp., Orange, CA) in February 2007. Clinical examination revealed a fractured abutment screw in which the apical portion remained inside the implant's internal connection. The screw was subsequently loosened and removed with the use of a sharp scaler and applying a counterclockwise movement to the fractured component within the implant's internal connection. Once the broken screw

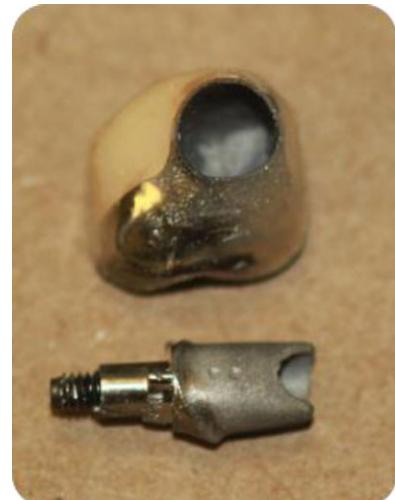
**Figure 3** Successful cement burnout and separation of crown from abutment.

The cement-retained, implant-supported restoration was embedded in a refractory firing block (Fig 2) and placed in a porcelain furnace (VITA Vacumat 500; VITA Zahnfabrik, Bad Sackingen, Germany) at 350°C. The block was placed in the furnace for 5 minutes, holding the temperature at 350°C under no vacuum. Once the programmed firing cycle was over, the block was set aside to cool. With the aid of two crile forceps (Miltex Integra, LifeSciences Corporation, Plainsboro, NJ) clamped on both components, the prosthetic parts were successfully separated by exerting a pulling movement, and a new screw was placed inside the abutment (Fig 3). Residual cement was carefully removed from the intaglio surface of the crown and from the abutment using a steam cleaner (Eureka Hot Shot; White Consolidated Industries, Cleveland, OH). The retrieved abutment was placed on the implant (Fig 4), and a periapical radiograph was taken to verify absolute seating to the implant platform. The abutment was tightened to 35 Ncm, and the screw access hole was filled with cotton pellets and a polyester urethane dimethacrylate composite resin material (Fermit; Ivoclar Vivadent Inc., Amherst, NY). The crown was cemented using zinc oxide non-eugenol cement (TNE; Temrex Corp., Freeport, NY) (Fig 5). Any excess cement was carefully removed, and a final periapical radiograph was taken to verify the absence of leftover luting agent. The occlusion was verified with the use of articulating paper (AccuFilm; Parkell Inc., Edgewood, NY) to detect any off-centric contacts and lateral excursive interferences that may have contributed to the loosening and subsequent fracture of the screw. The patient was scheduled for regular recall every 4 months.

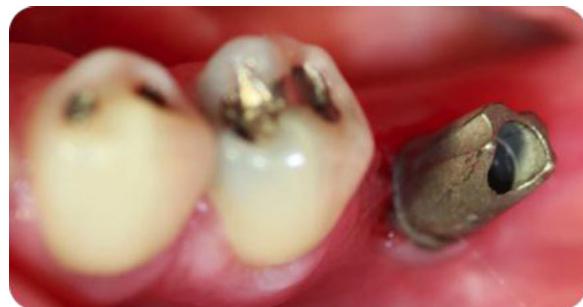
**Figure 4** Abutment reseated and torqued to 35 Ncm.

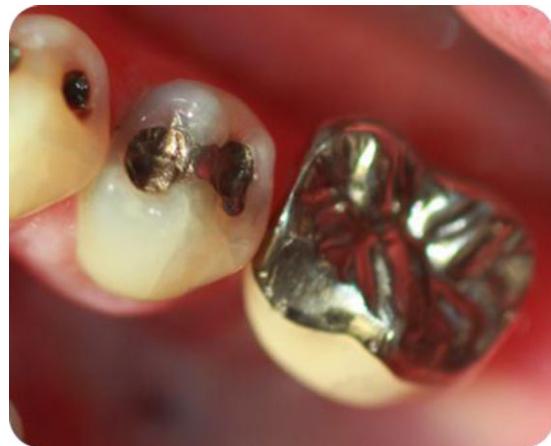
**Figure 5** Crown recemented.
