Human Histologic Evidence of Reosseointegration Around an Implant Affected with Peri-implantitis Following Decontamination with Sterile Saline and Antiseptics: A Case History Report

The treatment of peri-implant disease is one of the most controversial topics in implant dentistry. The multifactorial etiology and the myriad proposed techniques for managing the problem make successful decontamination of an implant surface affected by peri-implantitis one of the more unpredictable challenges dental practitioners have to face. This article presents the first known published case report demonstrating human histologic evidence of reosseointegration using a plastic curette for mechanical debridement and dilute sodium hypochlorite, hydrogen peroxide, and sterile saline for chemical detoxification. Guided bone regeneration in the infrabony component of the peri-implantitis lesion was accomplished using calcium sulfate and bovine bone as grafting materials and a porcine collagen barrier for connective tissue and epithelial exclusion. Int J Periodontics Restorative Dent 2017;37:499–508. doi: 10.11607/prd.3037

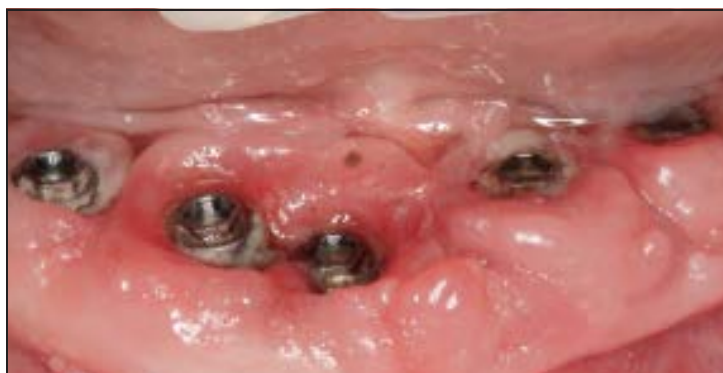
Fig 1 Preoperative photo of plaque and calculus accumulations and soft tissue inflammation around all implants.

The patient was placed on amoxicillin 250 mg and metronidazole 250 mg tid for 10 days beginning 1 day prior to the surgery. He was anesthetized at the beginning of the procedure using 2% lidocaine with 1:100,000 epinephrine (DFL). The mandibular restoration was removed and a red, inflamed gingiva that bled on probing was visualized around all five implants (Fig 1). All

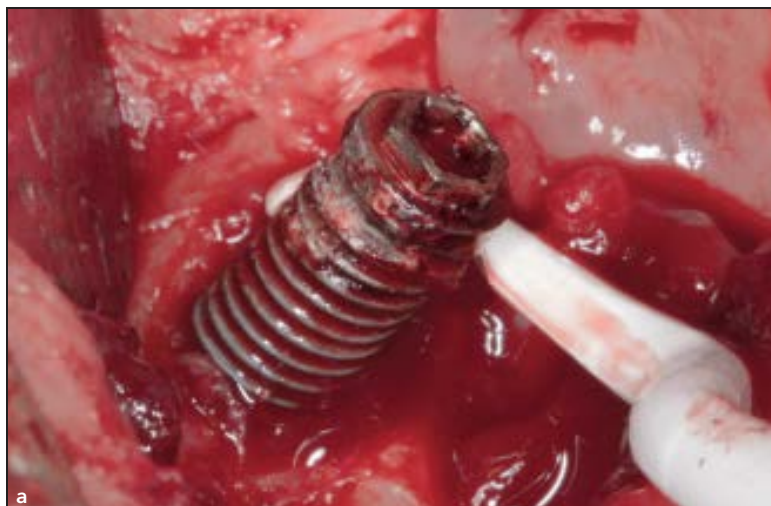
Fig 4a A plastic curette is used in a circular direction around each implant thread to remove or disrupt the plaque and calculus on the implant surface.

While heavy plaque and calculus accumulations were originally present on the implant threads (Fig 4a), the supracrestal surface was free of bacteria and relatively free of mineralized debris on reentry. Small particles of calcified material did remain within and around the micropores of the surface (Fig 9b). As a microbiologic assay was not performed it is not possible to determine whether the absence of soft tissue adherence was due to the calcified material remaining, residual endotoxin on the implant surface or within the screw access opening, or epithelial downgrowth due to the inherently weak nature of the connective tissue adherence to titanium.

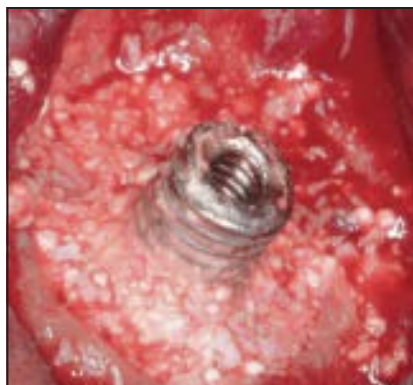
Fig 5a (left) The infrabony defect has been filled with a 50:50 mix of nanocrystalline CaSO_4 and bovine bone.

Nanocrystalline calcium sulfate (CaSO_4) (Nanogen, Orthogen) and small-particle bovine bone (BB) (Bio-Oss, Geistlich) were used to graft the infrabony defects. Equal amounts by volume of each were combined and hydrated with the setting liquid provided with the CaSO_4 . The mix was then incrementally packed with moderate density into the apical aspect of the defects, with an effort made to obtain close graft-to-implant surface approximation 360 degrees around the implant. Successive increments of bone mix were hydrated and layered on top of the first mix and also used to graft the socket where implant 2 had been removed (Fig

5a). Once the defects were filled and the excess graft material removed, the holes in the porcine membranes were carefully placed over the heads of the implants and the membranes were maneuvered apically until they covered the bone grafts and rested on the buccal and lingual plates and the interimplant ridge (Fig 5b).

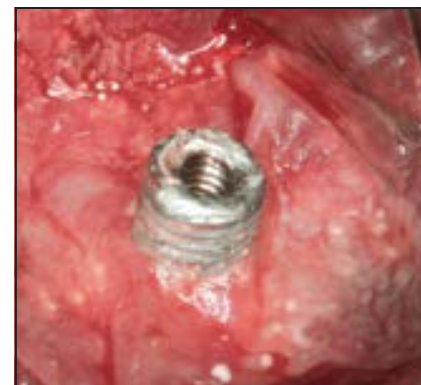
Fig 5b (right) A porcine collagen membrane with a 4-mm-diameter opening in the center has been placed over the test implant to completely cover the graft.

The porcine membrane used for guided bone regeneration was chosen for its handling characteristics. The punch technique allowed the membrane to be closely adapted 360 degrees around the implant, fully covering the bone graft (Fig 5b).

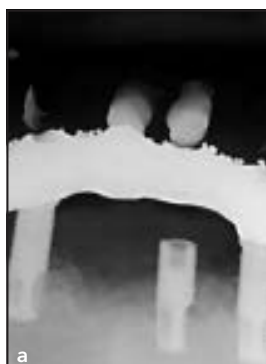
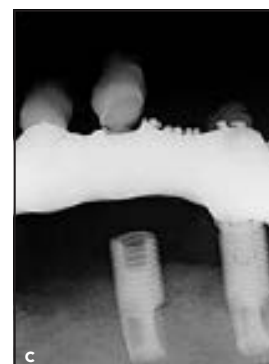
Fig 6 Postoperative radiographs at (a) 1 week, (b) 4 months, and (c) 6 months showing bone levels around the test implant.

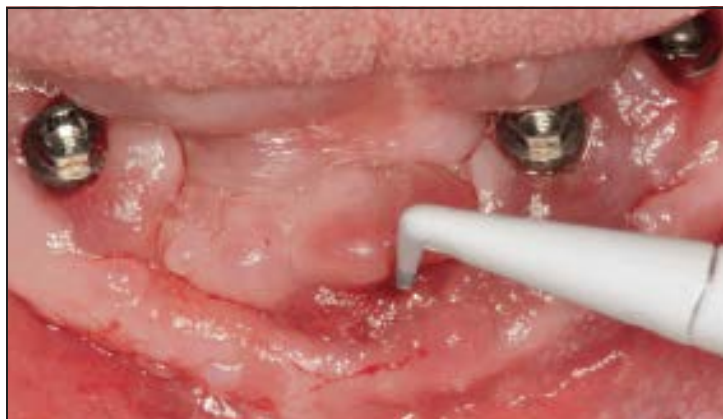
Fig 7 At the time of reentry, a probe could be inserted through a small communication by the head of the test implant.

At reentry, a small soft tissue communication that allowed for the insertion of a periodontal probe was evident over the top of the test implant (Fig 7). Following flap reflection, the coronal bone fill in the infrabony defect around the test implant was quantified by counting the number of exposed threads. Eight threads were exposed, 5 within the walls of the residual infrabony defect (Fig 8).

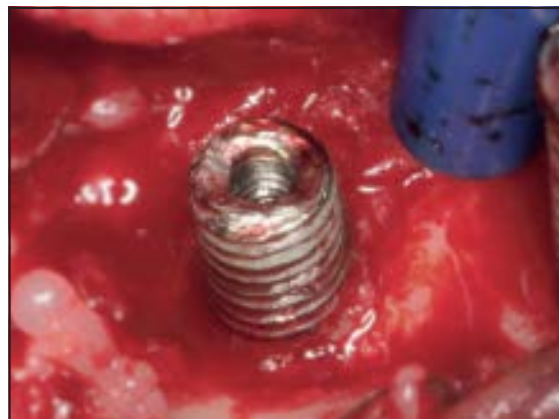
Fig 8 Bone fill is visible around the test implant on reentry. A total of 8 implant threads are now exposed, 5 within the confines of the infrabony defect.

There were eight exposed threads within the confines of the infrabony defect initially and five at the time of reentry. The three threads of new direct bone-to-implant contact in the photomicrographs confirm what was evident clinically and translate to a defect reintegration percentage of 37.5%. With an implant thread pitch of 0.6 mm, the height of new bone against the implant was calculated to be 1.8 mm. As human clinical reentries have been published showing what seem to be greater percentages of new bone-to-implant approximation in narrow infrabony defects,^{20,21} it
