Late Dental Implant Failures Associated with Retained Root Fragments: Case Reports with Histologic and SEM Analysis

The goal of this case report is to present radiographic, scanning electron micrographic (SEM), and histologic findings of two cases of late dental implant failures associated with retained root fragments.

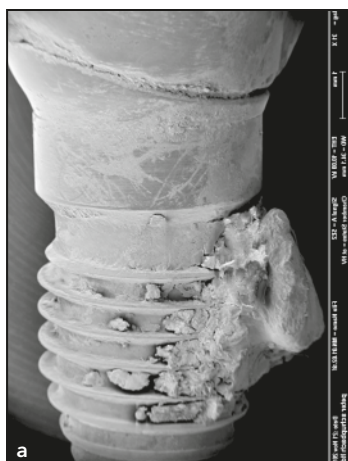
Fig 3 Scanning electron micrograph (SEM) demonstrating hard tissue attached to the mesial surface of the implant. (a) $\times 31$ magnification. (b) $\times 62$ magnification. (c) $\times 911$ magnification. I = implant; R = root fragment; C = calculus.

The SEM evaluation of the implant/abutment/crown system revealed hard tissue attached to the mesial surface of the implant (Fig 3). The SEM analysis revealed extensive bacterial infiltration on the surface of the implant and calculus formation consistent with peri-implantitis (Fig 4) and the presence of thick biofilm on the implant.^{21,22} The calculus is layered on the implant surface, evidencing the extent and duration of peri-implant attachment loss.

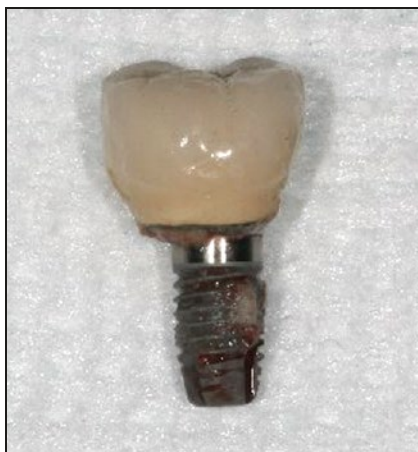
Fig 8 (left) Clinical view of retrieved implant (case 2).
